DEPARTMENT OF TRANSPORTATION

Quality Assurance and Source Inspection

Contract #: 04-0120F4Cty: SF/ALA Rte: 80 PM: 13.2/13.9File #: 69.15**SOURCE INSPECTION REPORT****Resident Engineer:**Pursell, Gary**Address:** 333 Burma Road**City:** Oakland, CA 94607**Report No:** SIR-000626**Date Inspected:** 14-May-2009**Project Name:** SAS Superstructure**OSM Arrival Time:** 0**Prime Contractor:** American Bridge/Fluor Enterprises, a JV**OSM Departure Time:** 12**Contractor:** Zhenhua Port Machinery Company, Ltd (ZPMC), Changxing Island**Location:** Changxing Dao, Shanghai

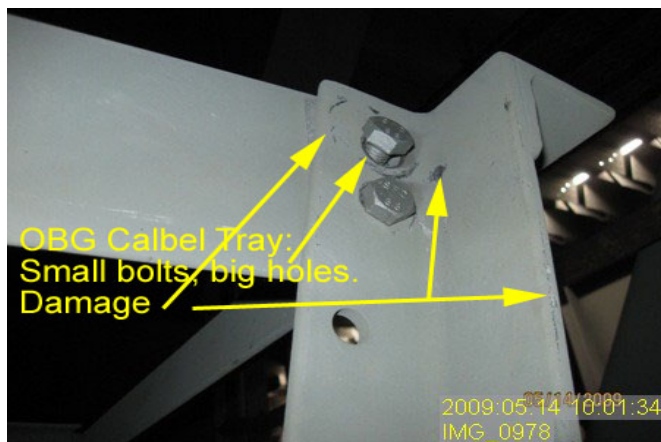
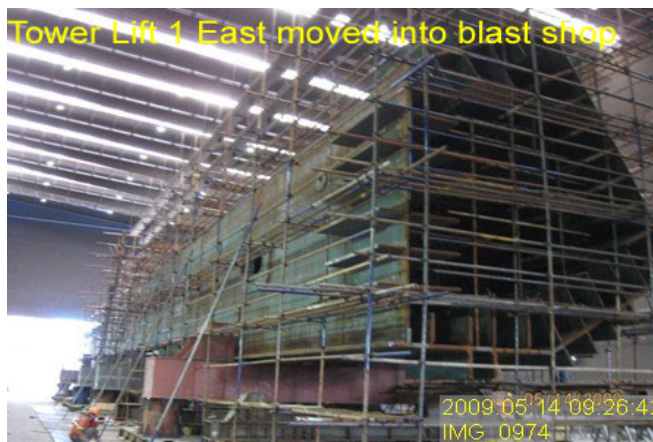
Caltrans QA Coatings Inspector Jordan observed several items in the trial assembly area that have received the final coat of primer. The final primer coating on these items have been damaged. The contractor has been informed.

Fabrication on assembled components of the OBG's are not complete. Coating damage requiring re-blast is expected.
